2003 Operations, Maintenance, and Monitoring Report

GIWW (GULF INTRACOASTAL WATERWAY) to CLOVELLY HYDROLOGIC RESTORATION

State Project Number BA-02 Priority Project List 1

July 8, 2004 Lafourche Parish

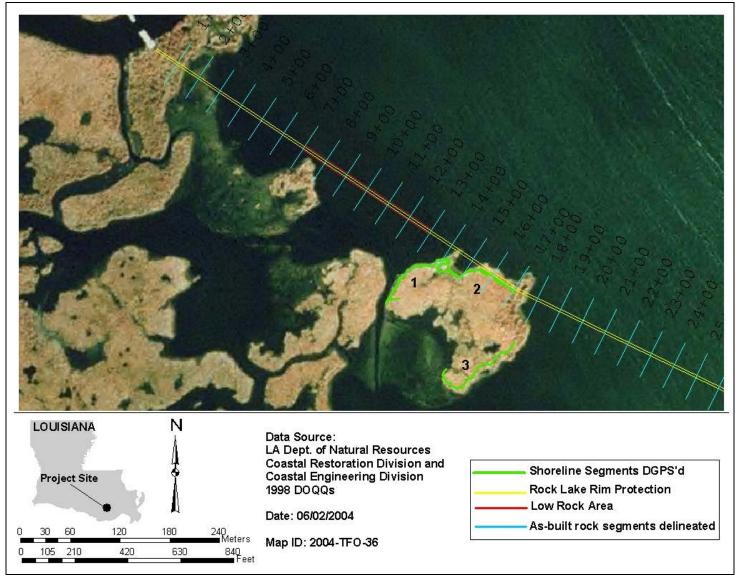
Figure 29. Low areas (7+00 through 13+00) along the lake rim rock dike in relation to the shoreline segments DGPS'd for change rates by DNR personnel for the GIWW to Clovelly Hydrologic Restoration (BA-02) project.

Overall, the project features of the GIWW to Clovelly Project appeared to be in good condition with only slight deficiencies noted in the inspection results such as slight settlement of the armored rock dike of the Lake Rim and several rock weirs, a large breach in the earthen embankment along a location canal south of Superior Canal and a small breach located along the bank of an existing location canal north of Brenton Canal. LDNR and NRCS agree that a cost effective approach to maintenance of these features is to delay the repair of the breached sections of earthen embankments until other maintenance items are identified for repair to be included under a single contract.

As a result of the 2004 Annual Inspection, LDNR and NRCS agree that no maintenance work is needed at this time. However, there are several areas along the rock dike and earthen embankment which have settled or are breached which may require a reevaluation prior to the next annual inspection. It is recommended that on future site visits LDNR will visit these locations and assess the condition of these structures and determine a plan of action, should one be needed.
